130 E Sprague Ave.
Spokane, WA 99202
P: (800) 437-7201
www.alliantroofing.com
info@alliantroofing.com

MAINTENANCE REPORT

PROJECT NAME	ADDRESS	INSPECTOR & DATE
Commercial Building	555 N 5 th Ave.	John Doe 1/2/20

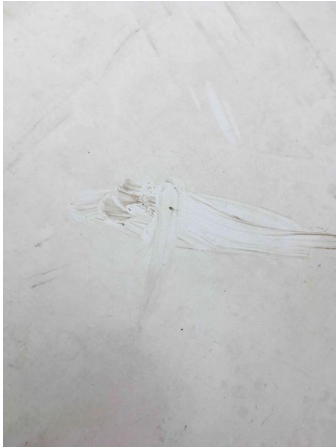
2a

**CONDITION 2****VOIDS**

Clean and prime existing voids in and repair

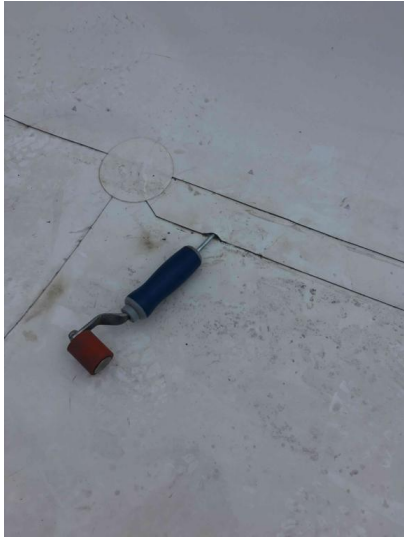
3a

CONDITION 3**SEAM PATCH**

Apply proper EPDM material over all improperly repair work
