MAINTENANCE REPORT

| PROJECT NAME | ADDRESS | INSPECTOR & DATE |
|---|---|---|
| Commercial Building | 555 N 5 th Ave. | John Doe 1/2/20 |

Upon inspecting the roof system at 555 N 5th Ave. Inspected all roof penetrations, drains, and walls for any faulty welds or damage. Cleaned any debris from roof. Upper east roof leak area is a condensation issue that the customer will address. Lower west roof leak area we found 3 holes 1 void and 25' of T-bar that was not caulked. We cleaned and patched all holes and void. Caulked T-bar with NP1 sealant. Two Technicians, total of 6 hours, 1.5 on leaks.

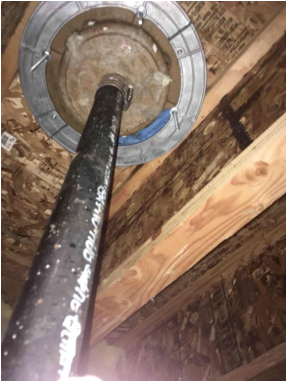
| PHOTO KEY | RECOMMENDED REPAIRS |
|---|--|
| 1a - 1d | Located leak and repaired. Found condensation issue on upper east roof |

LEAKING & CONDENSATION

Clean and prime existing voids and repaired

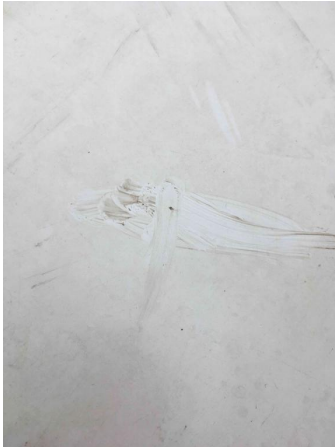
| PHOTO KEY | RECOMMENDED REPAIRS |
|---|--|
| 2a - 2d | Located voids and repaired |

VOIDS

Clean and prime existing voids in and repair

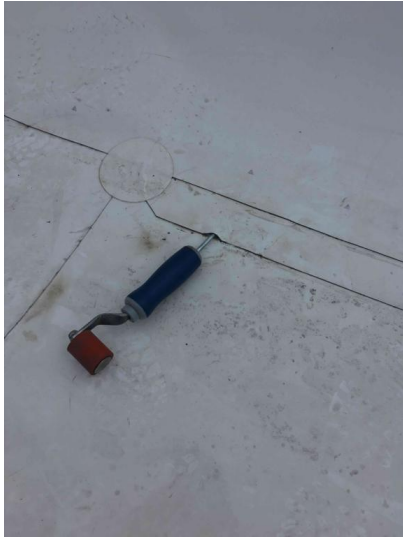
| PHOTO KEY | RECOMMENDED REPAIRS |
|---|--|
| 3a - 3b | Found failed seam and patched |

SEAM PATCH

Apply proper TPO material over all improperly repair work

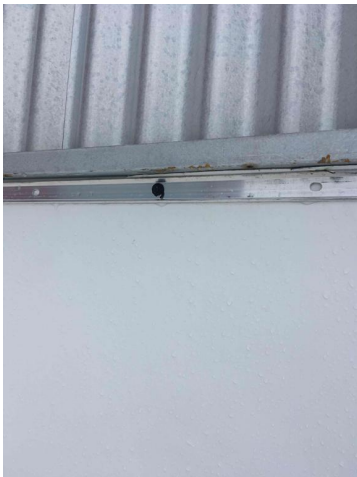
| PHOTO KEY | RECOMMENDED REPAIRS |
|---|--|
| 4a - 4d | Applied NP1 sealant to termination bar |

APPLIED NP1 TO TERMINATION BAR

Re-caulk termination bar

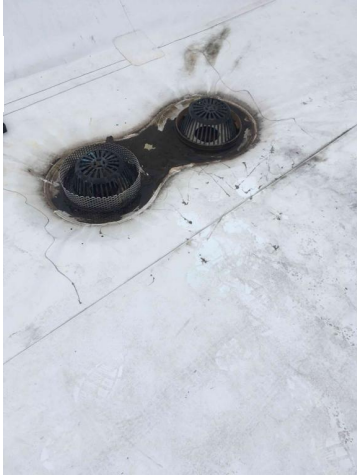
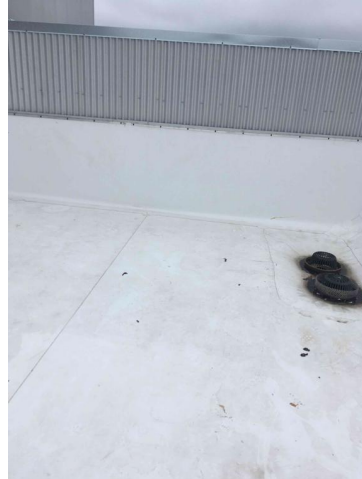
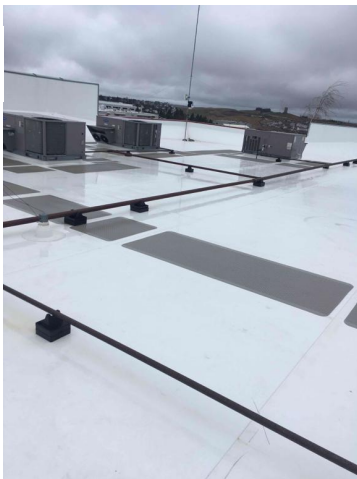
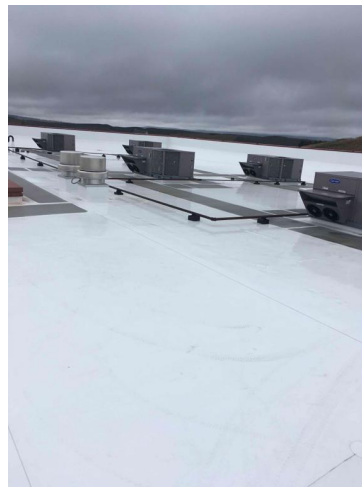
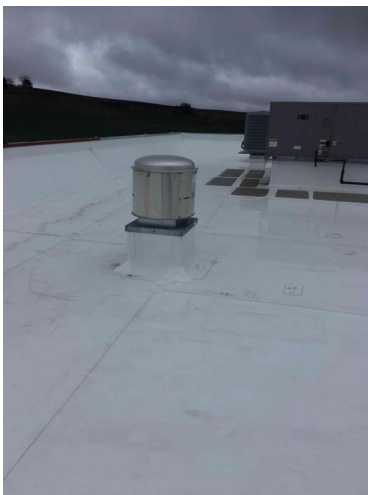
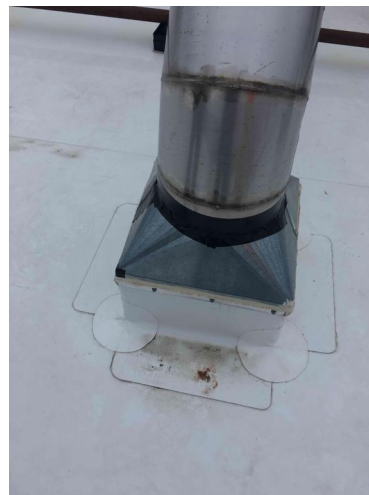
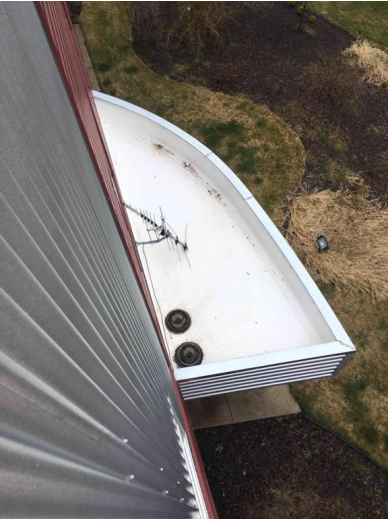
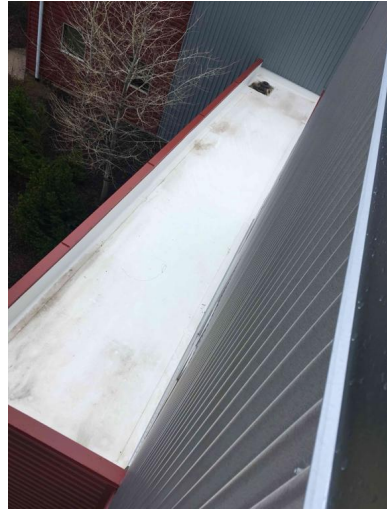
| PHOTO KEY | RECOMMENDED REPAIRS |
|---|--|
| 5a - 5h | Performed maintenance on entire roof |
